CONNECTICUT RIVER BASIN
SHERBURNE, VERMONT

KENT POND DAM
VT 00071

PHASE I INSPECTION REPORT
NATIONAL DAM INSPECTION PROGRAM

JUNE 1981

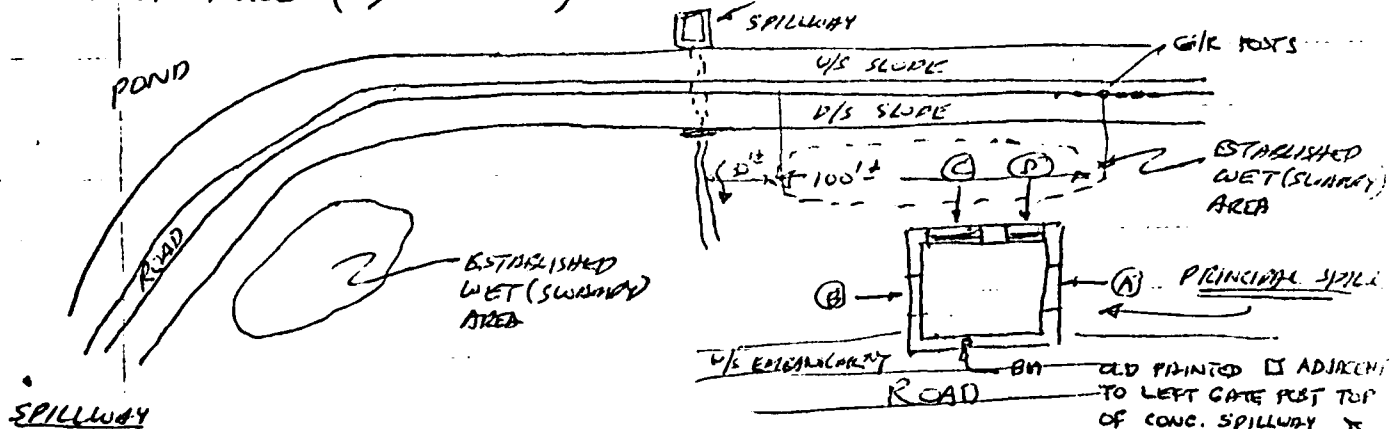
TRANS RAILS @ C @ AT SPILLWAY STRUCTURE

- SMALL LOGS CAUGHT ON RAILS
